NURail2013-MTU-R08

Rail Embankment Stabilization Needs on the Hudson Bay Railway

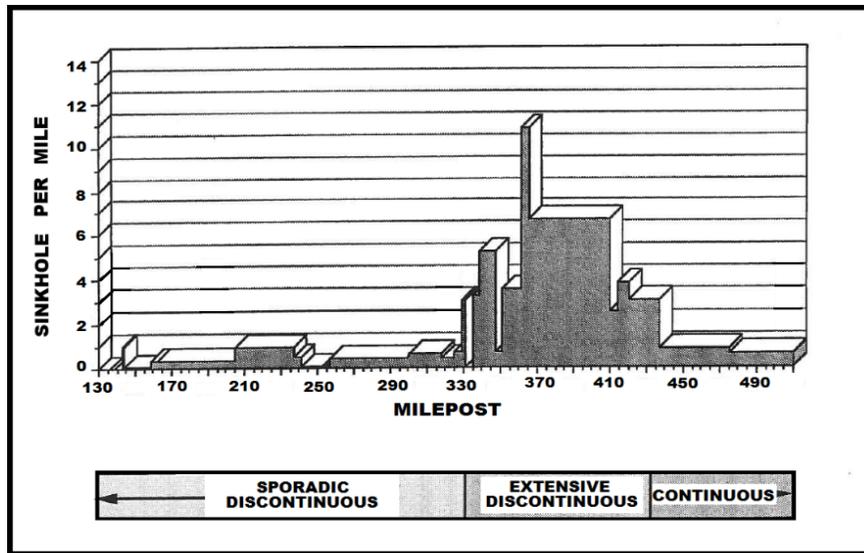
Figure 2. Sinkhole distribution along the HBR (EBA, 1990)

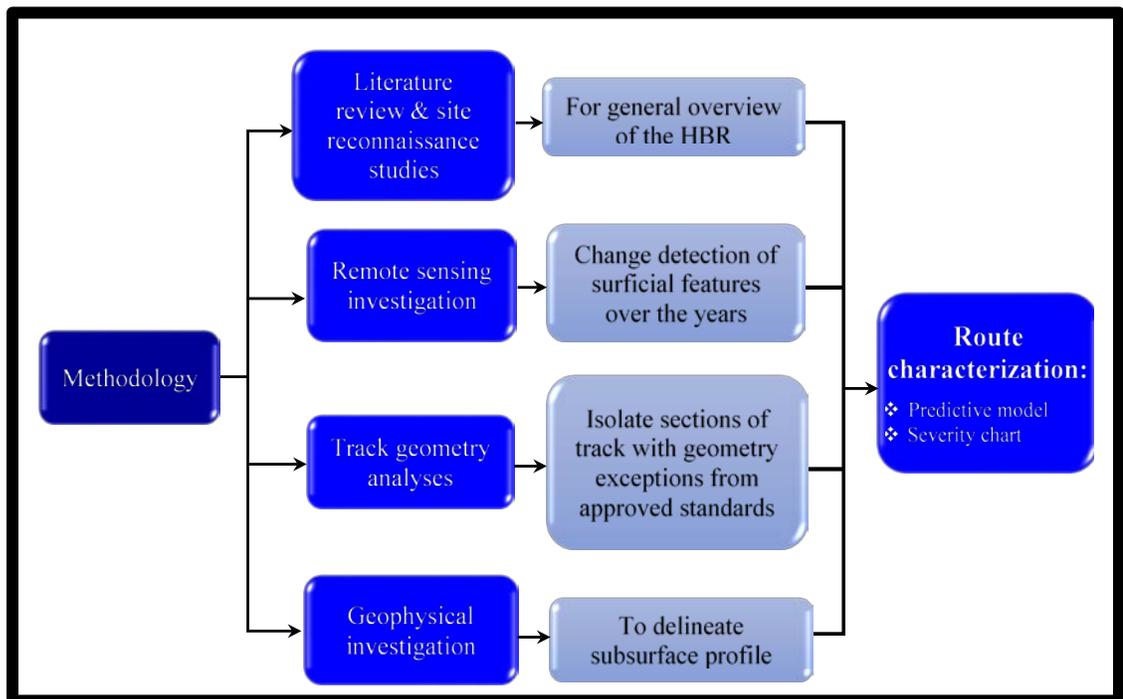
Objective 1 and the first part of objective 2 formed the main focus of the project and the approach has been summarized in Figure 3, followed by brief explanations.

Figure 3. Flowchart of methods to achieve objectives 1 & 2

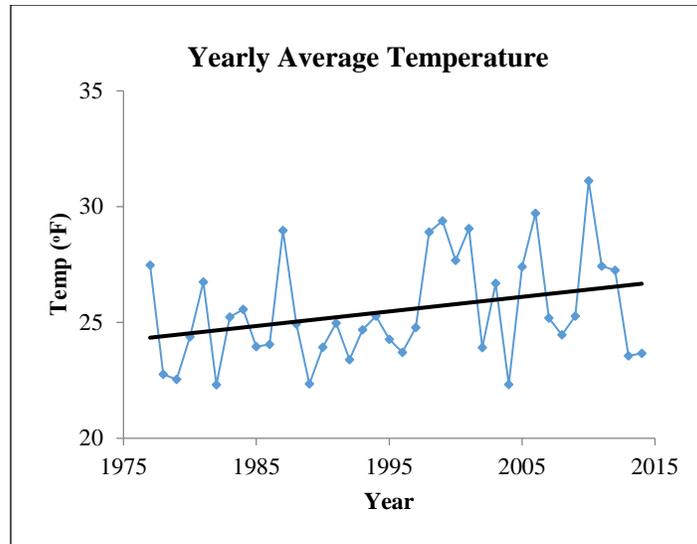
A plot of average air temperatures of the study location from EBA’s investigative period (1975) to 2015 revealed an upward trend (Figure 4). This increase suggests warming weather as a likely contributor to the degradation of underlying permafrost.

Figure 4. Average yearly temperatures from 1977 to 2014 (Gillam Airport Weather Station)

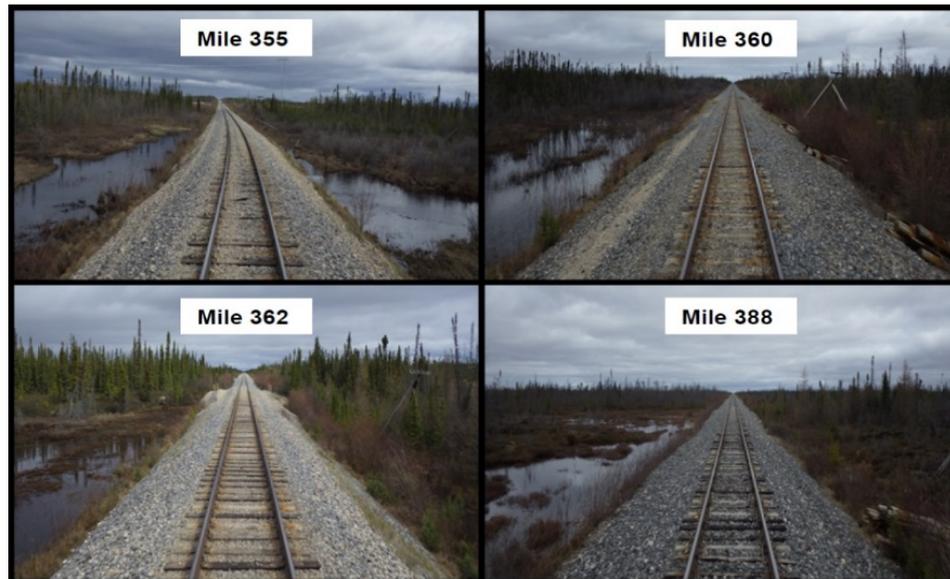
Geospatially located imagery acquired of the study area revealed that there were worsening drainage conditions, as one moves northwards in the discontinuous permafrost zone (Figure 5). Available literature has shown that poor drainage to be one of the contributing factors of permafrost degradation (Shur and Jorgenson, 2007); the ponded water conducts the sun's heat and transfers it to the underlying permafrost. This was evident at our study site, as locations with large areas of ponded water close to embankment shoulders recorded higher track geometry exceptions.

Figure 5. Drainage conditions found along the extensive discontinuous permafrost zone of HBR corridor

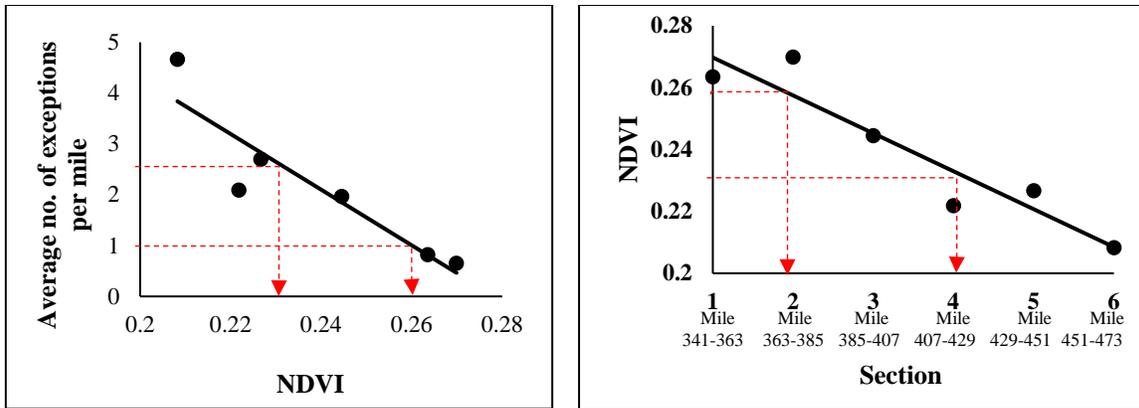
The results from remote sensing, track geometry analyses and the ERT analyses were used to develop an integrated permafrost degradation severity rating scheme and a three level degradation susceptibility chart (Figure 6 and Table 1). This rating chart can be used to delineate sections in the extensive discontinuous permafrost zone, based on susceptibility to permafrost degradation and related maintenance needs. The scheme used the *Normalized Differenced Vegetation Index* (NDVI) from the remotely sensed data, together with the average number of track geometry exceptions as an indicator of permafrost health. NDVI ranges from -1 to 1, representing no vegetation to highly vegetated areas, respectively. Low NDVI was found to correlate with high amounts of ponded water (poor drainage). An earlier study on using track exceptions to infer railway track performance conducted by researchers from the University of Alberta, Canada, found that locations along a track that recorded less than one exception per year are generally considered stable and within acceptable performance levels, whereas locations that develop more than 2.5 exceptions are of concern and need to be mitigated (Roghani et al., 2015).

Figure 6. Defining ranges for developing severity chart

A rating of 1 represents a low degradation susceptibility region, which for our study location was found to be between the southernmost mileposts 341 and 363. This region is predicted to develop at most one track exception per mile annually, is well vegetated and without ponded water (NDVI of 0.26 or higher). The region is rated as less susceptible to permafrost degradation. While not confirmed by this study, we would expect the section to be underlain by a thawed subsurface.

A rating of 2 represents a medium degradation susceptibility region, which was found to be between mileposts 363 and 407. This region is predicted to develop between 1 to 2.5 track exceptions per mile annually, with an NDVI between 0.23 and 0.26.

A rating of 3 represents the northernmost high degradation susceptibility region between mileposts 407 and 473. This region is predicted to develop at least 2.5 track exceptions per mile every year. It has minimal vegetation and water ponded close to the embankment shoulders, having an NDVI of 0.23 or lower. The region is rated as most susceptible to permafrost degradation due to the fact that it is likely underlain by an actively thawing permafrost table with many transition zones.

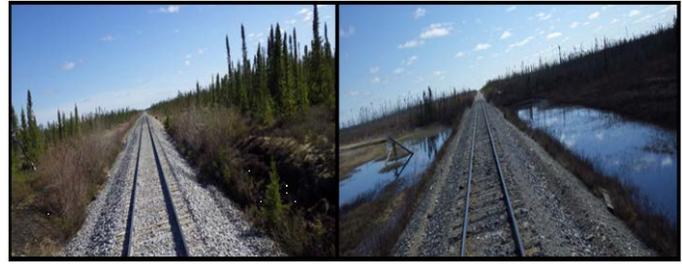
Figure 2. Typical sections of peat plateau (left) and fen (right)

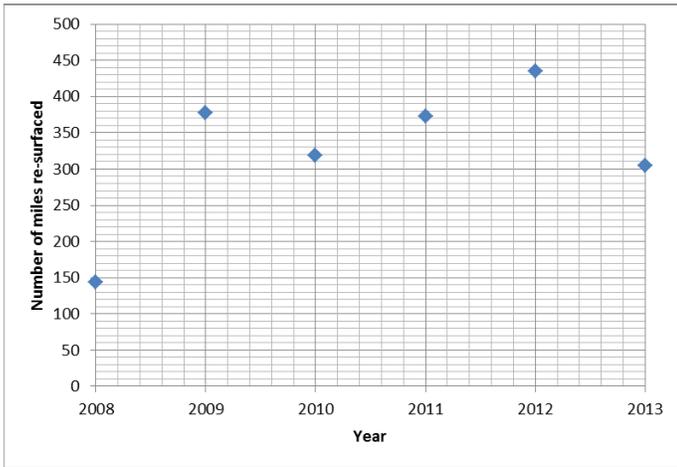
Figure 3. Number of miles re-surfaced each year due to thaw settlement

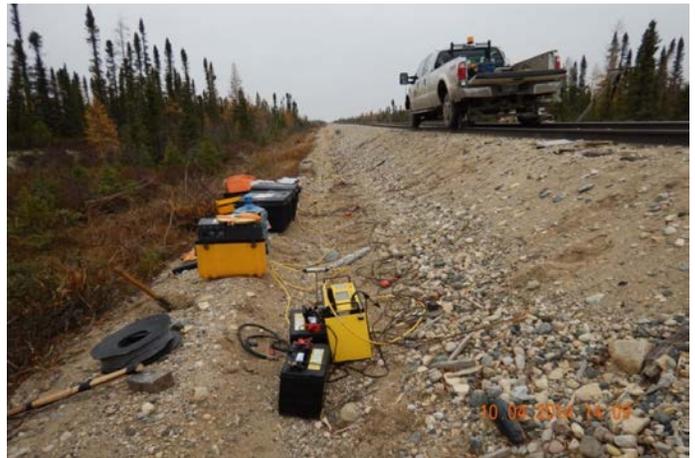
Figure 4. Running surveys at an offset distance parallel to the rail embankment

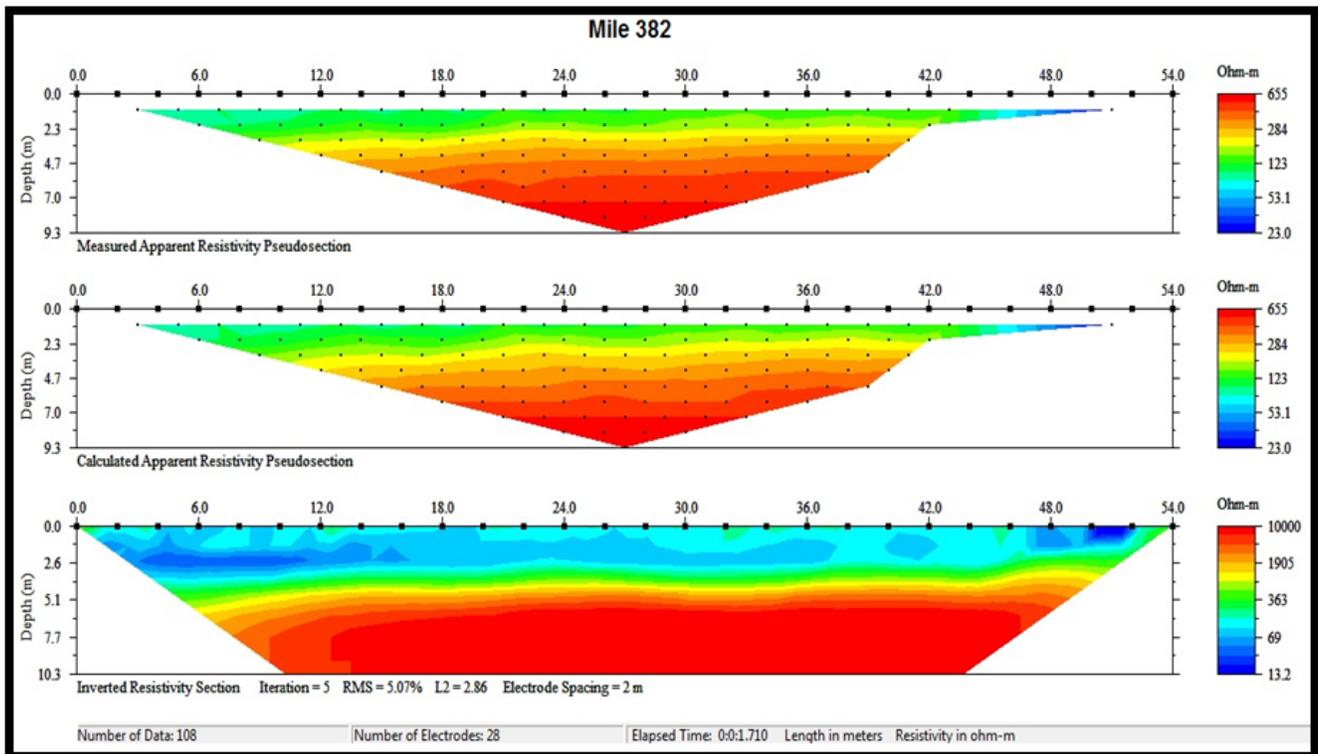
Figure 5. Results of ERT conducted October 2014 at milepost 382

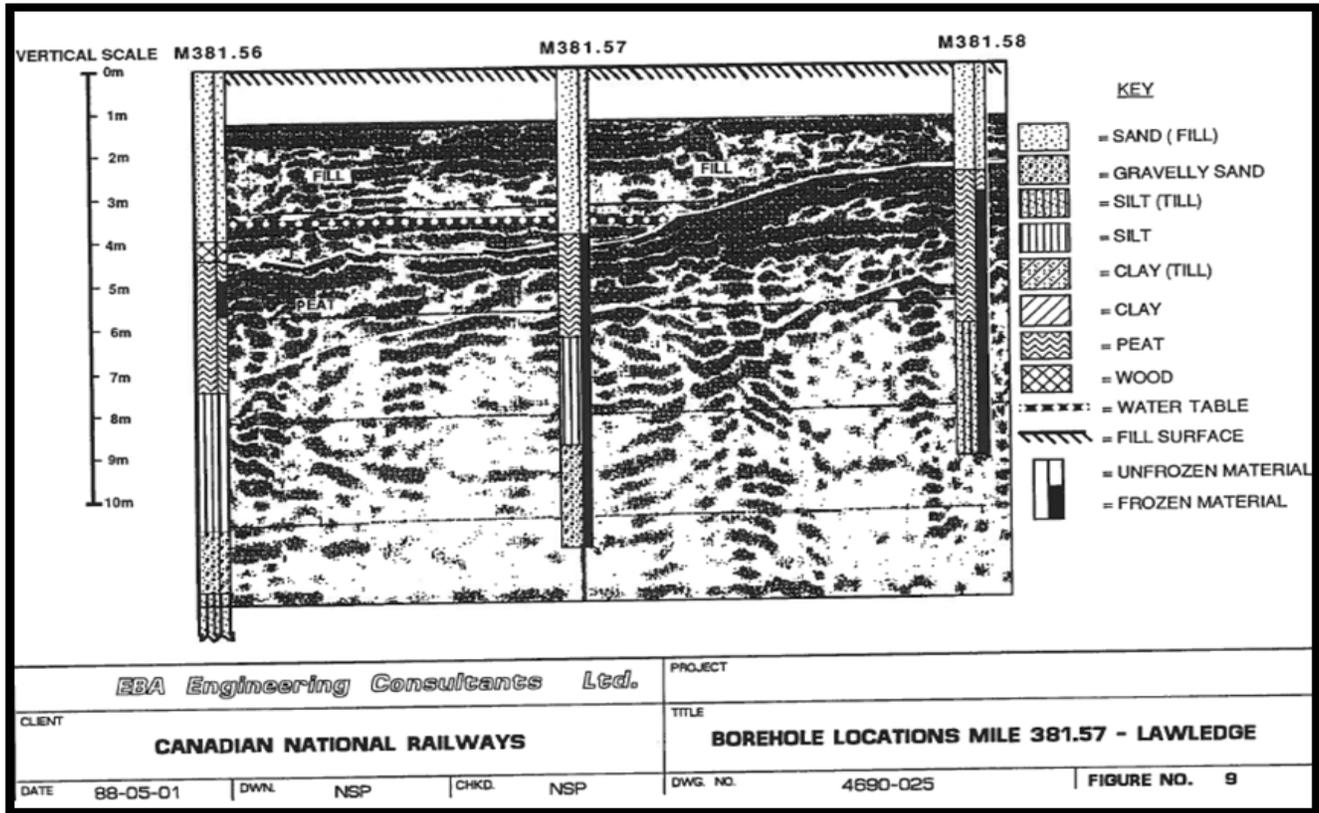
Figure 4. Borehole and GPR profile at Milepost 381.5 (EBA Engineering, 1987)

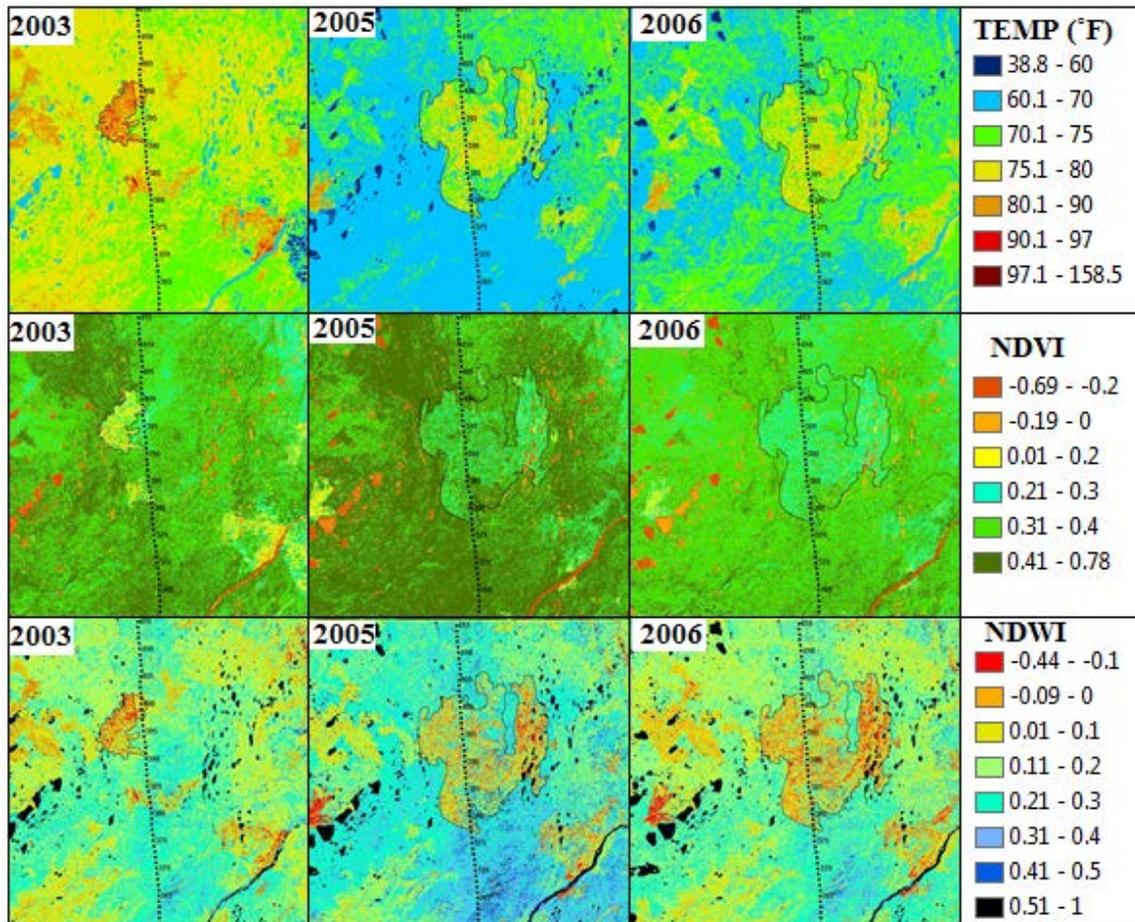
Temperature data from Landsat 5 TM band-6 revealed at least 18 incidences of wildfires in the proximity of the HBR from 1984 to 2010. The areas affected varied from small patches of about 7 square miles to big spreads of about 400 square miles. Increased LSTs from the fires were observed to last for at least three to five years. Figures 2 and 3 show the response of LST, NDVI, and NDWI to a fire that occurred in July 2003. This fire was of particular interest because its coverage encompassed a portion of the railway. It was interesting to note the progression of its coverage area from 26 square miles in July 2003, to 50 square miles in August 2003, and then to 300 square miles in July 2004. This indicates that the fire burned for a considerable amount of time, maybe even smoldered in the active layer throughout the winter. The portions of the railway that were affected were mileages 397 – 400 in July 2003 to mileages 377 – 402 in July 2004. The LST of the burned area was noted to be approximately 20°F higher than the neighboring unburned area in 2003 and 10°F higher after three years in the 2006 (Figure 3). A decrease in the NDVI and NDWI were observed within the burned area compared to the surrounding area in 2003 to 2006.

Figure 2. LST, NDWI, and NDVI images from the July 2003 wildfire.

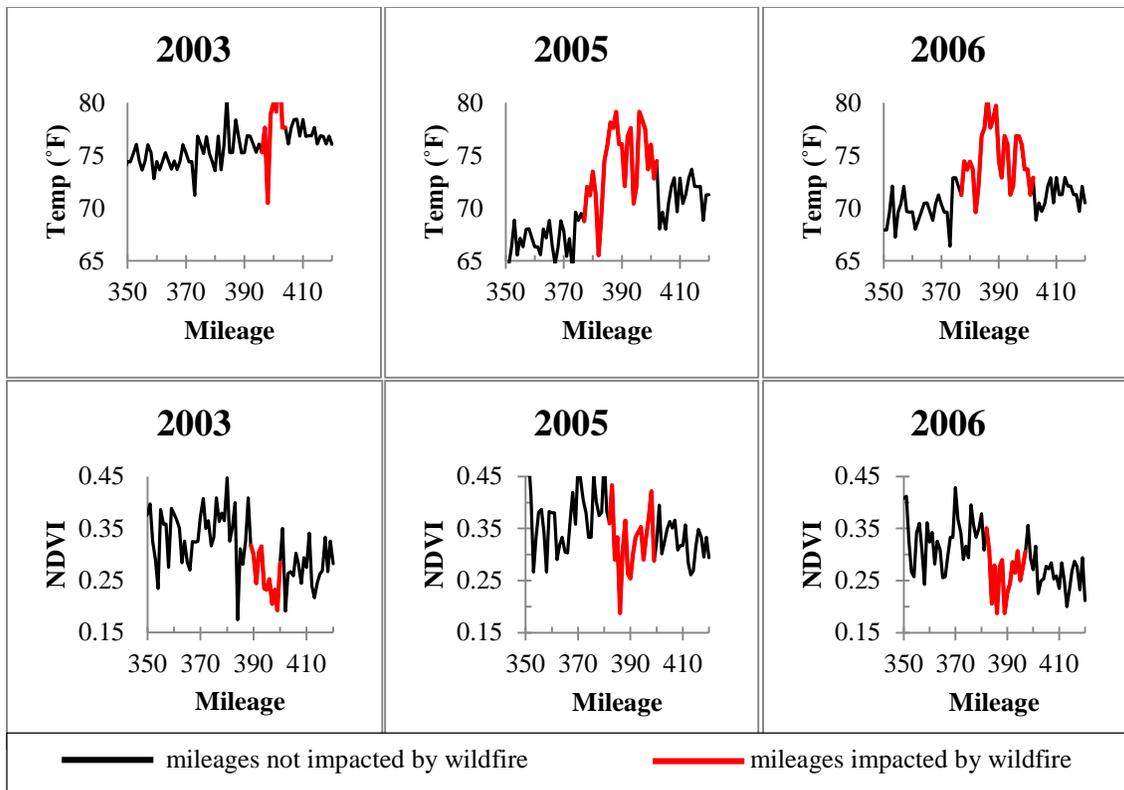
Figure 3. Cross-sectional profiles of LST (top) and NDVI (bottom).

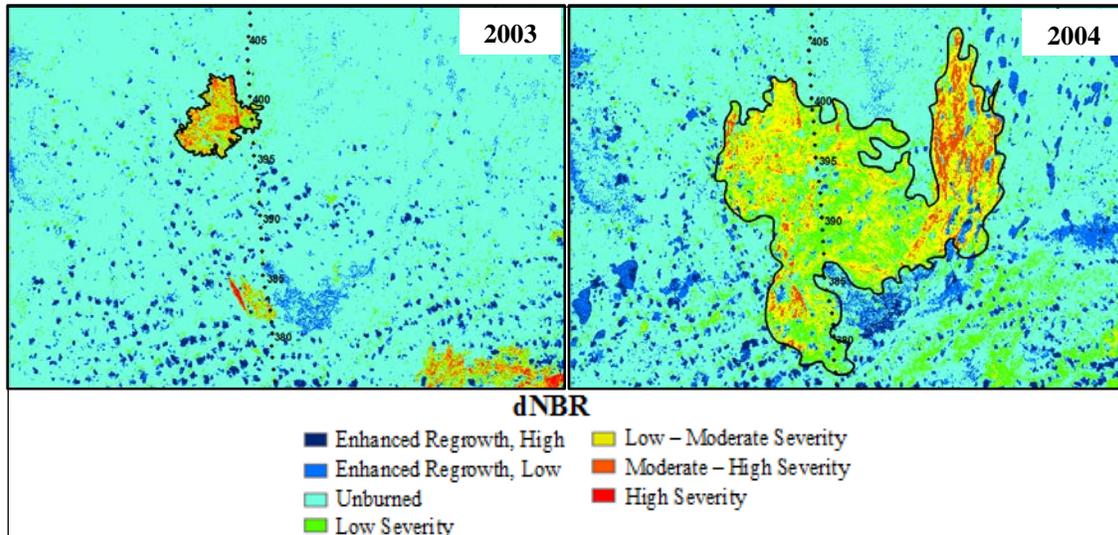
area experienced moderate to high burn severity in July 2003. Studies have shown that severe wildfires could result in permafrost degradation causing an increase in the active layer depth when at least 30% of the insulating organic layer thickness is removed (Jafarov et al. 2013). When fire removes the organic layer in a region where climate does not favor permafrost, which is characteristic of many discontinuous permafrost regions, it is likely the permafrost will undergo widespread degradation and will not recover even after vegetation regrowth (Shur and Jorgenson 2007). Based on this information, it is possible that any permafrost degradation that has occurred within the study area might be naturally irreversible.

Figure 4. dNBR images of July 2003 and July 2004 indicating the spread of the fire.

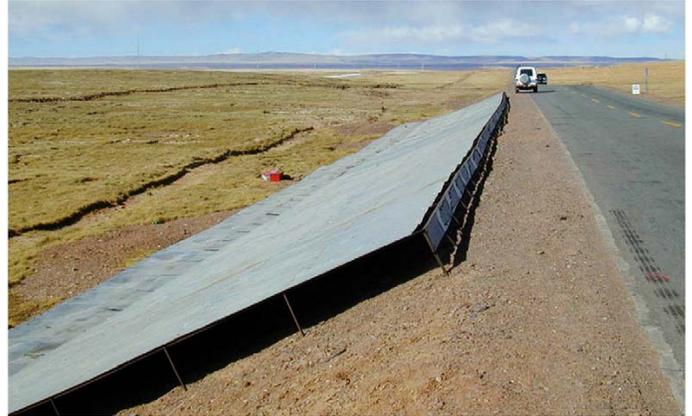
Figure 2. Shading boards installed along the Qinghai–Tibet highway [15]

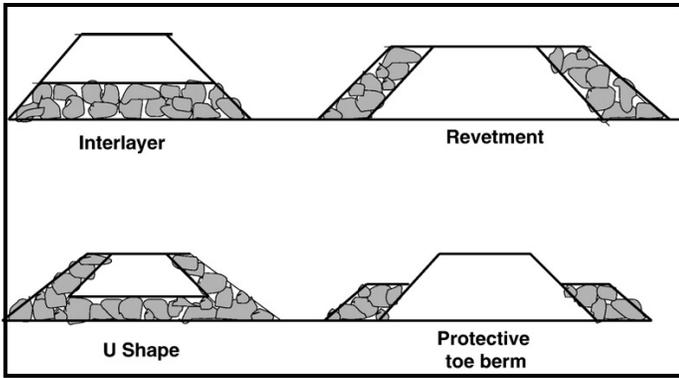
- Interlayer
- Revetment
- U-shaped
- Protective toe berm

Figure 3. Various embankment configurations [23]

The results indicate that the thicker the overlying fine-grained sand and gravel, the weaker is the cooling effect of the underlying rock layer. When the thickness of the overlying layer is greater than 18ft, sections of the embankment begin to lose their cooling effect [24].

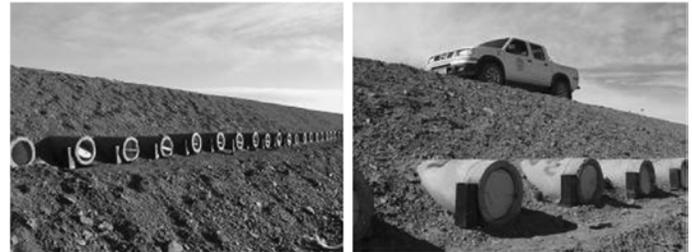
effect of increasing heat gain in the summer since hot air got trapped in the tubes. To curb this they designed a new system with temperature sensor controlled shutters (Figure 4). When the ambient air temperature of the surrounding is higher than a preset value, the shutter get closed, otherwise it is opened [36]. This proved to be effective as temperature measurements over time showed embankments with these new ducts to be 33°F colder than those of the old ones [37, 38].

Figure 4. Temperature-controlled ventiducts [36]

Ventiduct embankments require natural wind currents to remove heat from the embankment. Areas with sufficient drainage and minimal snow accumulation tend to suit these systems best, as such conditions facilitate air flow through the pipes. Differential settlements can reduce air flow and may also increase maintenance requirements and ultimately reduce effectiveness.

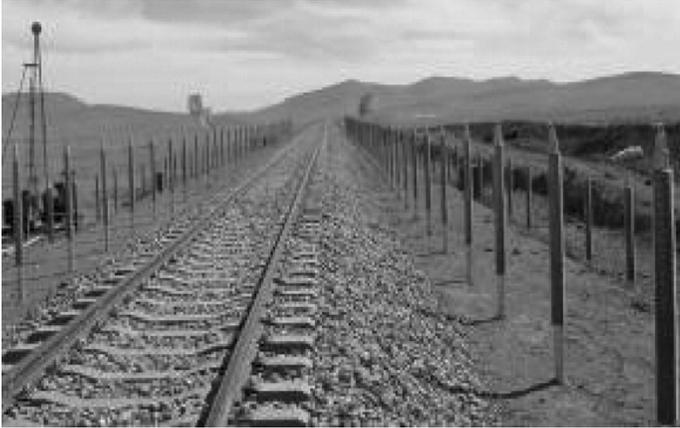
Heat pipes are very effective in cooling permafrost while guarding against heat transfer to the embankment in the summer months. They were first used along the Trans-Alaska Oil pipeline to successfully resolve the problem of transporting hot oil over permafrost. In the rail industry, the first known large scale use was along the Hudson Bay Railway at two 3-mile prototype testing sites. They successfully resolved about 90% of the settlement issues of the worse test site and even resulted in permafrost aggradation in some sections [40 – 42]. Thermosyphons have also been used at some of the most challenging locations along Qinghai-Tibet railway, in many cases together with other stabilization methods.

Figure 5. Thermosyphons [23]

Though effective, thermosyphons are very expensive. Hence, they are best suited for high risk sites with warm ice-rich permafrost. Damage during transport and operation is very detrimental as depressurization or obstruction of the cooling fins will render these devices useless [43].

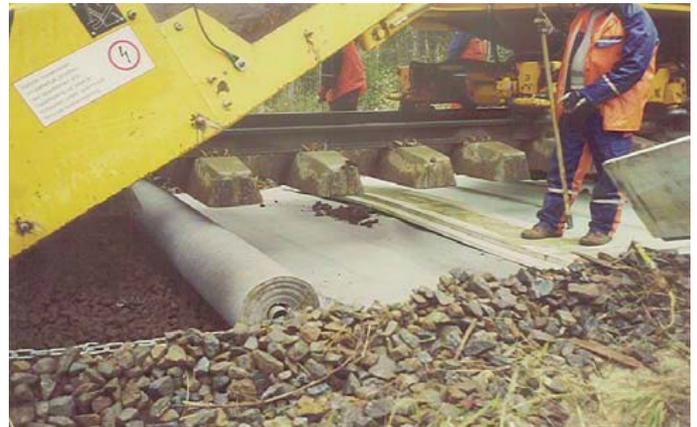
In addition to keeping the temperature of the embankment uniform, polystyrene also resists water absorption and offers good mechanical strength as resistance against cracks and indentations from overlying ballast and trains [44]. However, the long term results indicate that the thermal protection of insulation alone may not be sufficient [9, 39].

Figure 6. Expanded polystyrene insulation [45]

Insulation layers are best used in locations where there is the expectation of high magnitudes of solar absorption by embankments during the summer months. They can also be used to minimize the required construction depth of the embankment. Water absorption issues and mechanical damage can decrease life span and effectiveness so these factors should be designed against if possible [46 – 48].

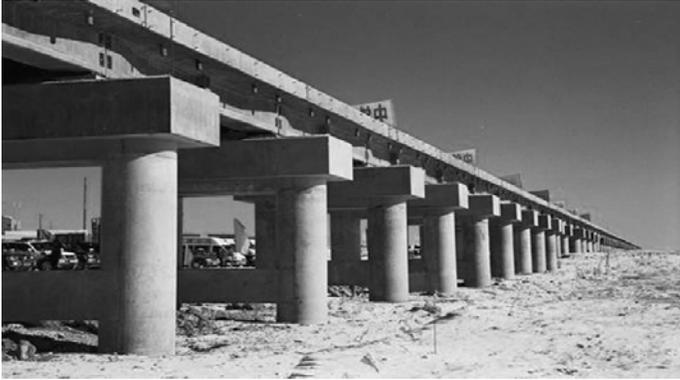
Cheng et al [23, 49] reports that a total of 78 mile length along the Qinghai-Tibet railway were fitted with dry bridges due to their very unstable nature (warm ice-rich permafrost). Monitoring efforts after their installation has indicated a maximum deformation height of 5mm so far, showing their effectiveness. It was further noticed that soils underneath them recorded lower temperatures than those without; depicting an added benefit of dry bridges shrouding the ground from direct sunlight and also allowing the free flow of convective winds underneath it which facilitates this cooling [50].

Figure 7. A dry bridge along the Qinghai-Tibet railway [23]

Possible failure modes include differential settlements of the piles if they are not founded on stable enough formations. They can also get damaged by natural disasters such as earthquakes, landslides or derailments. Preliminary research has shown this to be the most expensive of all the previously discussed methods and is therefore recommended to be utilized only in extremely thaw sensitive locations (warm ice-rich permafrost) [23, 49].

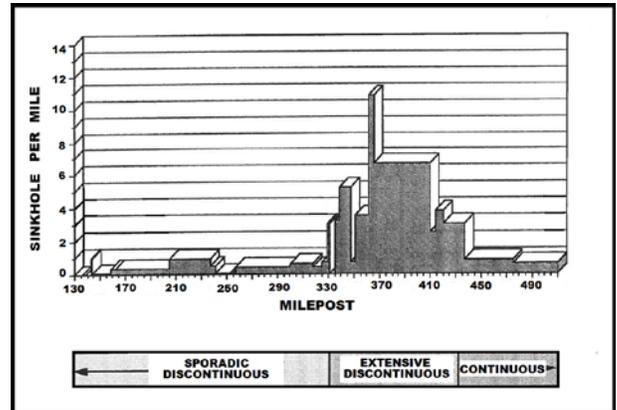
Figure 8. Sinkhole distribution along the HBR [52]

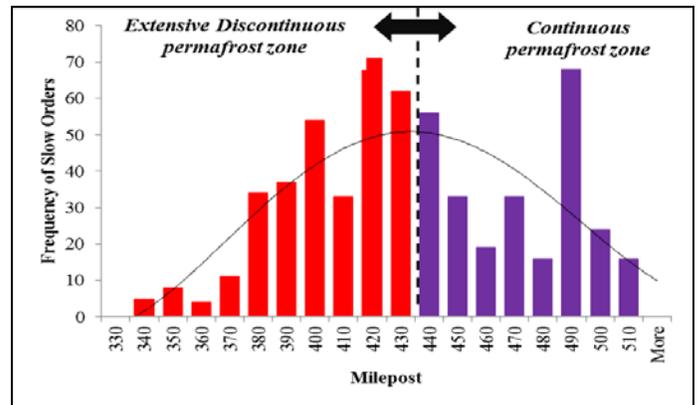
Figure 9. Summary of slow order frequency recorded along the HBR for 2014-2015

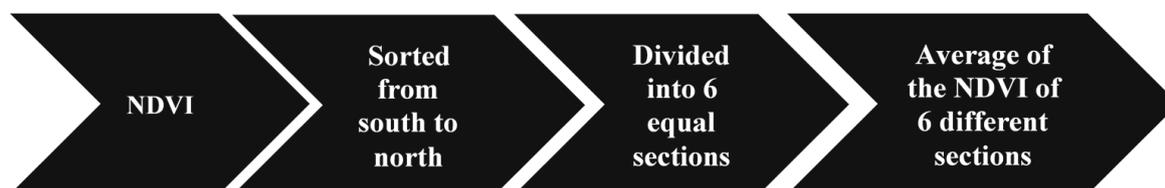
Results from the ERT surveys at the 10 sites were compared against the track exception data to identify trends between these datasets. The objective was to infer subsurface conditions delineated by the ERT from the surficial data of the track exceptions. After establishing this relationship, the NDVI from the remote sensing analyses was compared against their corresponding average number of track exceptions recorded. This analysis was modelled after Roghani et al.’s approach [31] by dividing the study section into 22-mile sections, resulting in six subsections from milepost 341 (southern end) to milepost 473 (northern end). The process is summarized in Figure 2. The corresponding track exceptions per mile of track were calculated by combining the recorded yearly average exceptions per section and dividing them by the segment length (22-miles).

Figure 2. Process for determining relation between NDVI and track geometry exceptions.

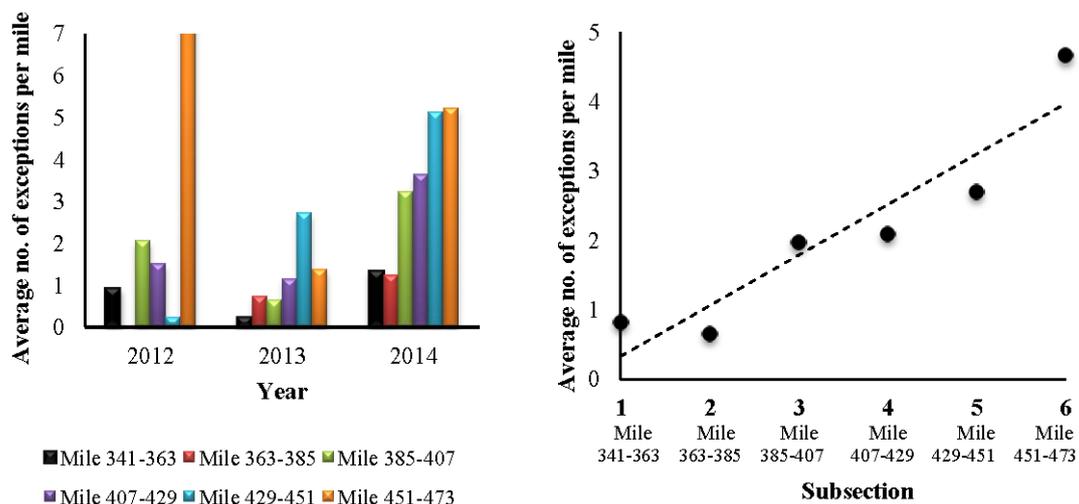
Based on these analyses, it can be concluded that locations with high track geometry exceptions are likely underlain by thawing permafrost and locations with few or no track exceptions are mostly devoid of permafrost. With this relationship established, the next step was to discern the relationship between track exceptions and vegetation trends.

Figure 3. A plot of track exceptions recorded for the six subsections in 2012–2014 (left); and a plot of the average track exception recorded for the investigative period for each subsection (right).

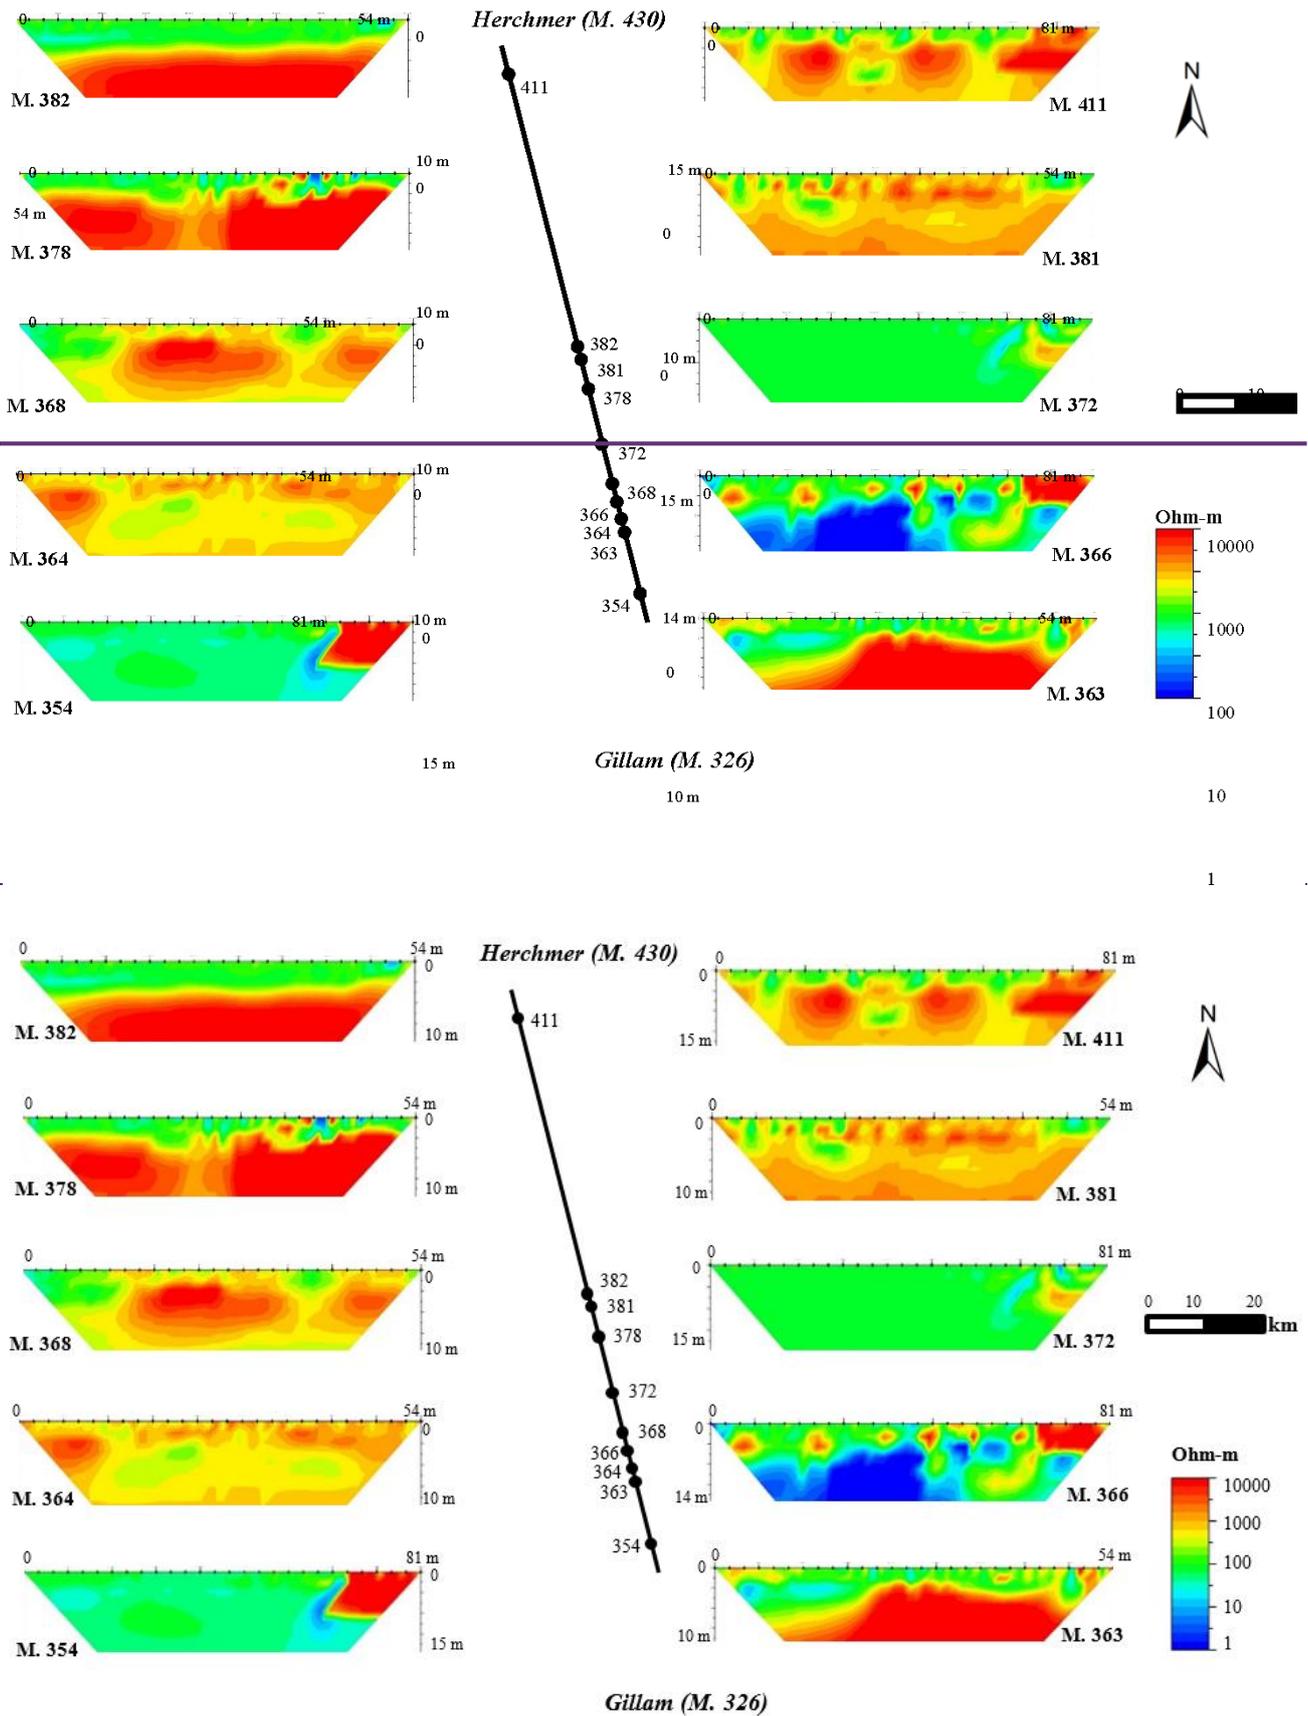
Figure 4. Subsurface profiles from the ERT investigation displayed along the track route of the study section, showing ground resistivities from low resistive thawed soils in blue to highly resistive permafrost layers in red color.

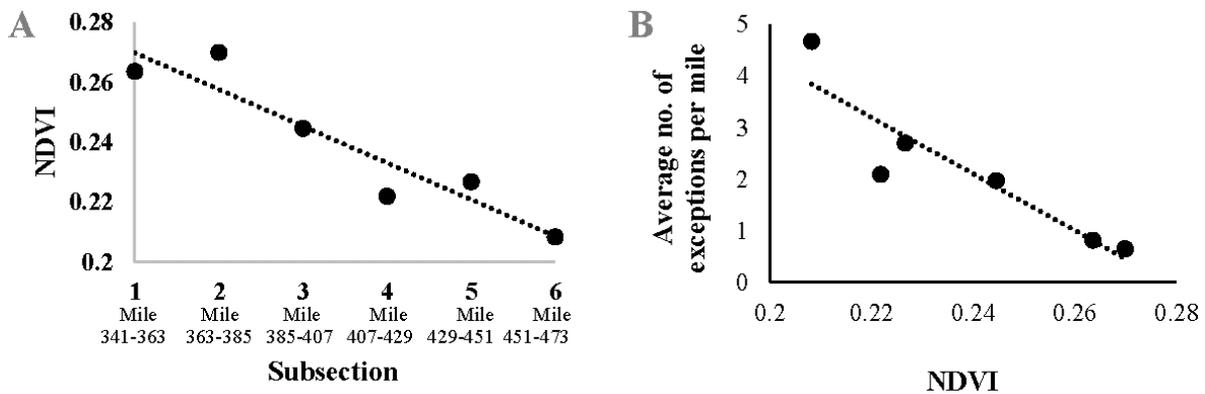
NDVI was compared against the corresponding average number of track exceptions recorded for each of the six subsections. A plot of the NDVI against subsection shows a general negative correlation from section 1 to 6 (Figure 5A), which indicates a decrease in the vegetation density as one moves northward. A plot of the NDVI versus the track exception also shows a negative correlation indicating that as vegetation decreases, the number of track exceptions increases and vice versa (Figure 5B).

Figure 5. A plot of track sections versus NDVI showing the tendency to find less vegetation as you move northwards (left); and NDVI versus track exceptions showing that it is more likely to find track exceptions in locations with little vegetation and vice versa (right).

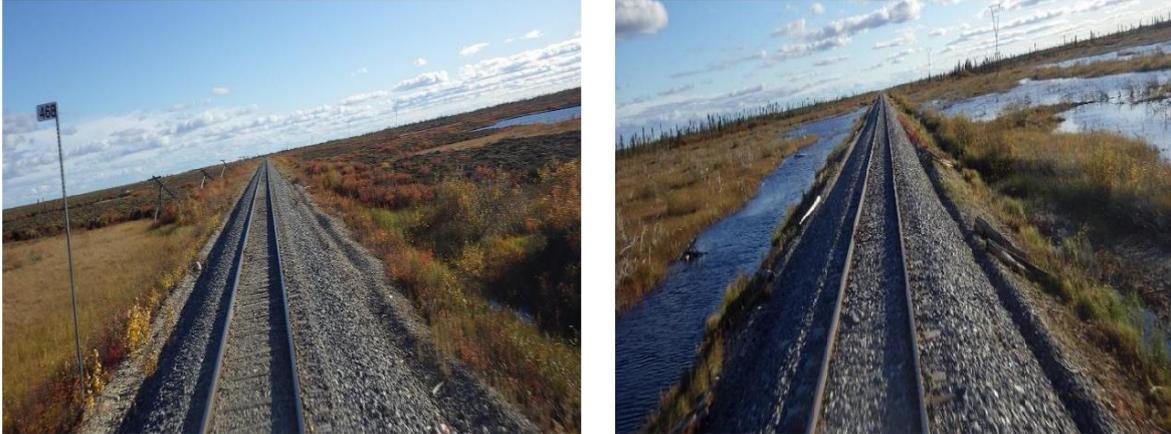
Photo images were taken in 10-second intervals while traversing the entire study area by a hi-rail truck. A comparison between the photos and research findings revealed that the northernmost sections with the lowest NDVIs (Subsections 5 and 6) are generally devoid of tree cover. This is intuitive; however, a more noteworthy finding was that these sections had substantial amounts of ponded surface water close to the embankment shoulders. Figure 6 shows two such typical images for milepost 468 (Subsection 5) and milepost 448 (Subsection 6). Conversely, the southernmost sections, which recorded the highest NDVIs, had denser vegetation with no surface water close to the embankment shoulders (Figure 7). From these photos, it was realized that the low NDVIs obtained for this particular study site translate not only to low vegetation densities but also to high percentage of ponded surface water.

Figure 6. Photos of milepost 468 (left) and milepost 448 (right) showing no tree cover and ponded water close to embankment shoulders.

These photos also reinforced the perceived relationship between the NDVI and track exceptions, as past literature have shown collected waterbodies in the form of ponds and lakes have deleterious effects on underlying permafrost. Ponded water absorbs the sun's heat and transfers it to the permafrost table [33], which explains why the northernmost sections recorded higher frequencies of track exceptions, indicative of permafrost degradation.

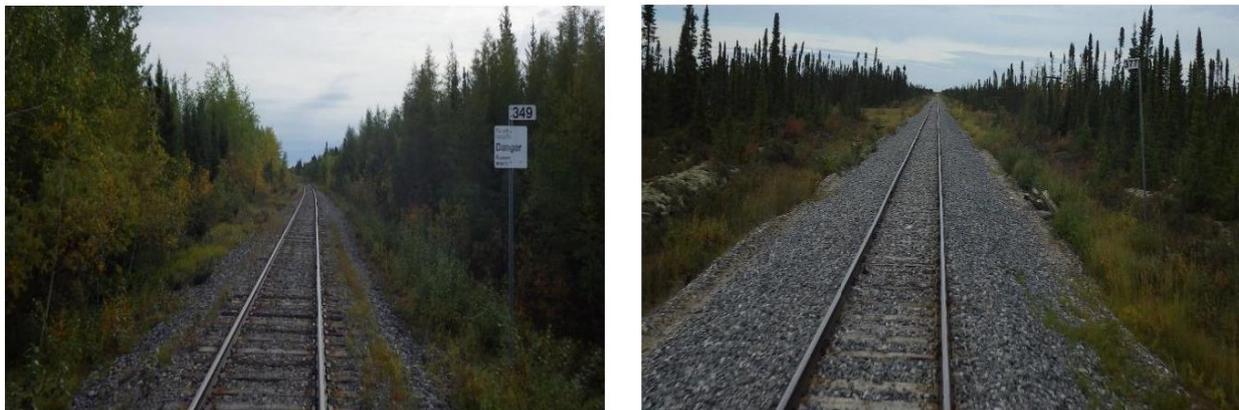
Figure 7. Photos of milepost 349 (left) and milepost 377 (right) showing population of trees and no surface water ponded close to the embankment shoulders.

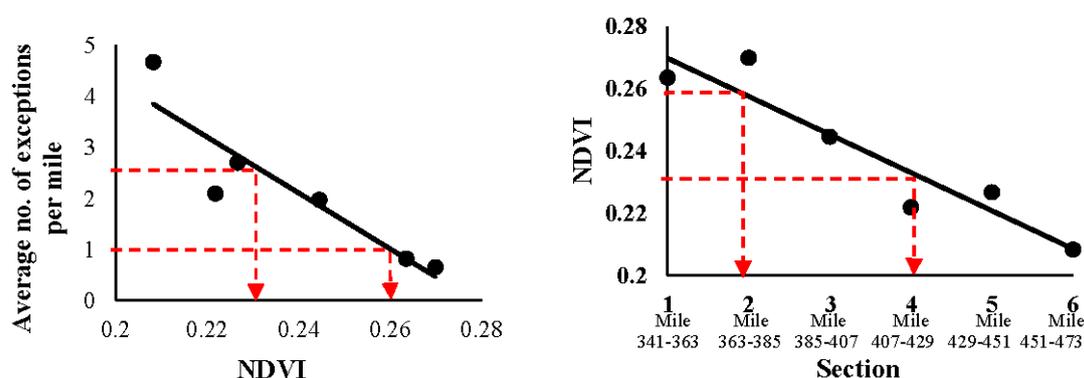
The average number of exceptions recorded was used as the basis of the chart. Locations that developed a maximum of one exception per year were generally considered stable and within acceptable performance levels, whereas locations that developed more than 2.5 exceptions are of concern and need to be mitigated [31]. Using these two track exception limits, a three-level severity chart was developed. The results are summarized in Figure 8 and Table 1.

Figure 8. Defining percentiles for developing severity chart.
